Clear Cupboard Villa, Farmington

by P. E. Gascoigne
1969, Vol. 88, 34-67

Clear Cupboard Villa, Farmington, Gloucestershire

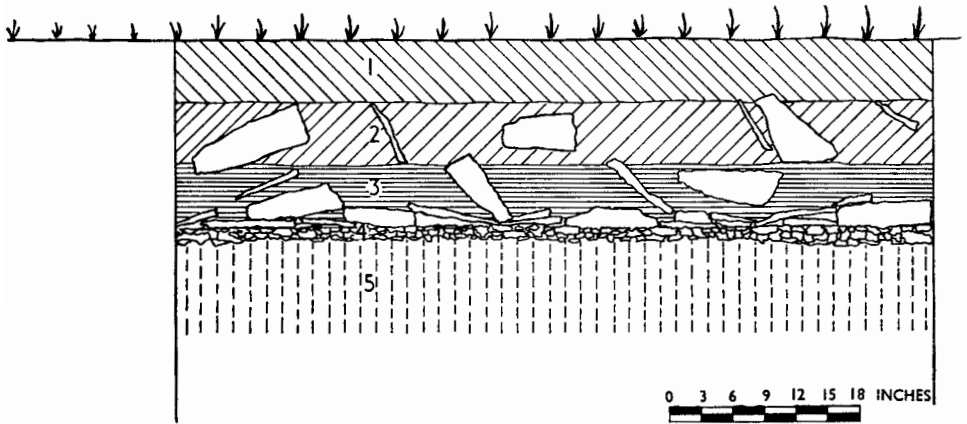
Fig. 2. Cross section, western interior

| 1. Black humus with small stones. | 3. Darker soil, gravel, small stones, roofing slabs (mostly broken) and walling stones. |
| 2. Dark brown soil with gravel, small stones, some walling stones and fragments of roofing slabs. | 4. Rammed stone floor. |
| | 5. Limestone brash. |

Although the excavation was to some degree in the nature of a rescue 'dig,' the method of excavation employed was horizontal stripping, initially leaving temporary baulks for access to the working areas and for the removal of spoil. This gave a grid effect in the early stages. The first six inches of soil was removed with spades, excavation below this level being done with trowel and brush. Mechanical equipment was only used to remove the overburden along the length of drain running from the plunge bath and for back filling. There was virtually a total absence of stratification due to the shallow depth of overburden, the short duration of occupation and disturbance by deep ploughing. Only in the western interior of the main building were horizons in the soil profile discernible (FIG. 2).

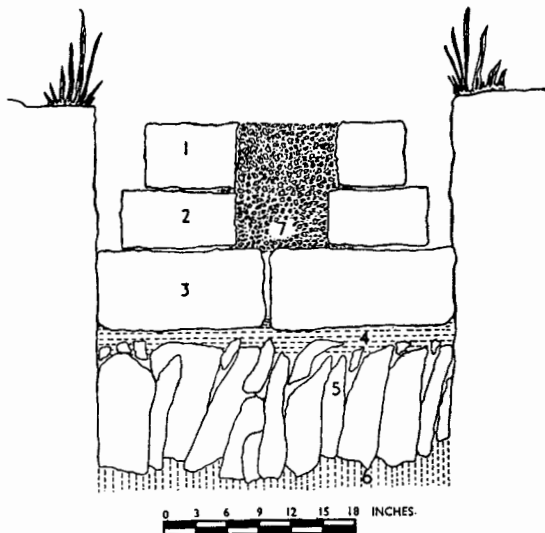
Fig. 3. Main building, cross section showing construction of exterior walls

| 1. Wall width | 5. Random pitched stone. |
| 2. Off-set course. | 6. Limestone bed. |
| 3. Foundation course. | 7. Mortar and small rubble in-fill. |
| 4. Mortar. | |

The external walls of the main building were constructed by cutting a straight sided trench no greater than the width required through the top soil and loose brash to a firm bottom. Into this were placed thinnish stones packed tight together on edge for greater load-bearing strength. A covering of mortar levelled this random pitching to receive the first course of masonry, large roughly dressed slabs. The second course of smaller better dressed stones was set back and the third course stepped back a similar distance to give the width at which the wall was to be carried up (FIG. 3). The wall stones of local Jurassic limestone had their exposed faces squared, the other sides being left irregular and tailed back into the core of the wall. The masonry courses were carefully laid in a good mortar, each course, apart from the first, being about 6 ins. deep. The wall cavity was filled with stone rubble, bonded with mortar.

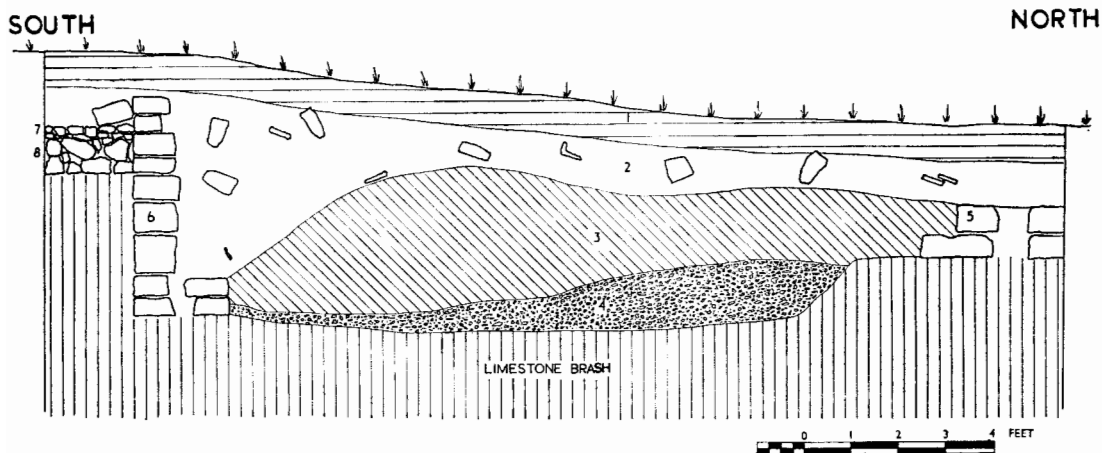
1. Black humus with small stones.
2. Dark gravelly soil with stone rubble, scattered fragments of flue tiles and tufa.
3. Light brown, very gravelly with perished wall plaster and cement, fragments of flue tiles and tufa.
4. Similar to 3 but with limestone brash rubble.
5. North wall of main building.
6. South wall of bath suite.
7. Rammed stone floor.
8. Sub floor.

N.B. Note hard shoulder bordering north wall of main building.

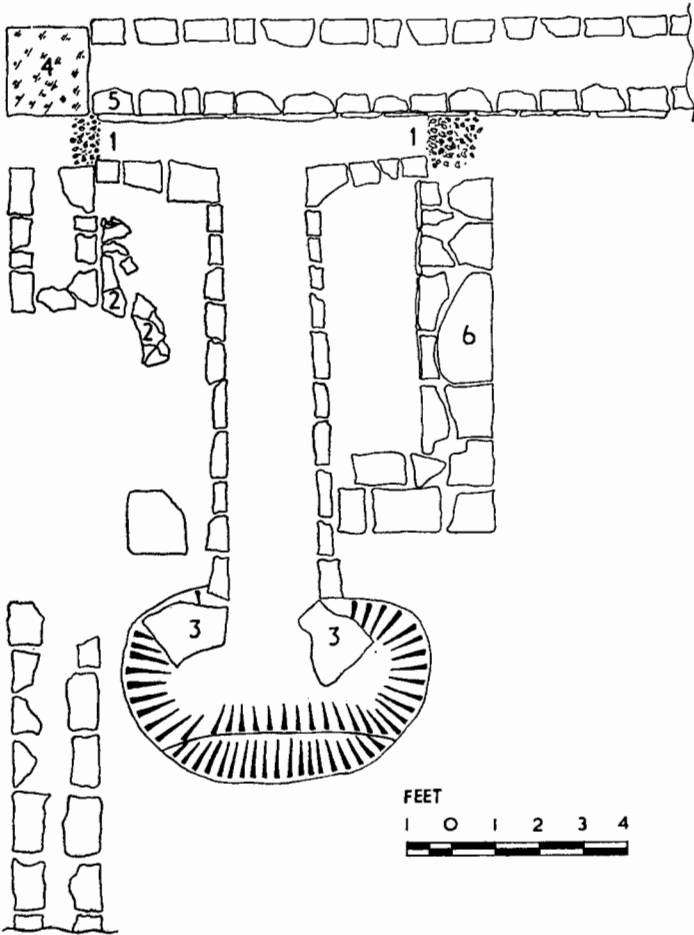
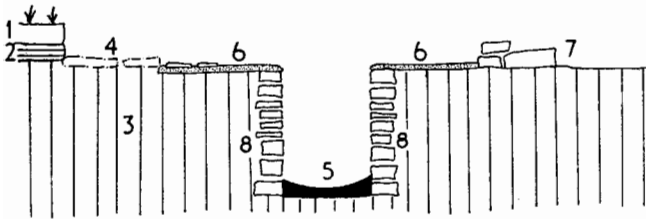
Fig. 5. Barn building, corn drying oven

1. Limestone brash at end of T-flues.
2. Fragments of burnt stone slabs (roof slabs), sub-floor of dryer.
3. Stones with traces of slots.
4. Corner stone of main building.
5. Walling stone with pivot hole.
6. Parapet wall of dryer.
7. Stoke hole dug into brash.
8. Limestone brash step.

| 2. Light brown soil with gravel. | 6. Sub-floor with burnt stone slab fragments. |
| 4. Line of outside wall—robbed or ploughed away. | 8. Retaining walls of main flue. |

Room IV—Provides more certain evidence with a ‘T’ shaped corn drying oven, possibly a threshing floor and a flagged passage to a rickyard, the possibility of corn in ricks being suggested by the stone for holding thatching (see The Finds—Stone, S17). If grain was

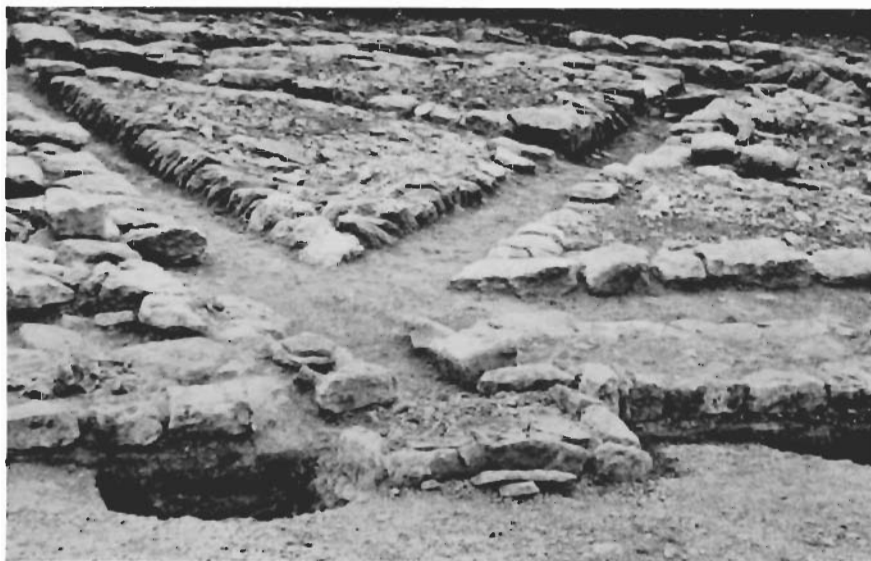
PLATE I. a. Site as seen from north side of valley
b. Room I, Hearth with ash pit

Interior measurements 27 ft. 6 ins. — 15 ft. 10 ins. The floor of *opus signinum* was laid over the clean natural limestone brash. Against the south wall lay a hearth 2 ft. 6 ins. by 1 ft. 7 ins. with associated ash-pit 2 ft. 0 ins. by 1 ft. 3 ins. by 10 ins. deep which was found to be full of wood ash when excavated. A channel from the back of the hearth led through the main wall to the hypocaust channels in Room VI (PLATE 1b). Walls of this room had been rendered with painted wall plaster. Quarter-round plaster moulding was found at the junction of wall and floor in the south-west corner of the room.

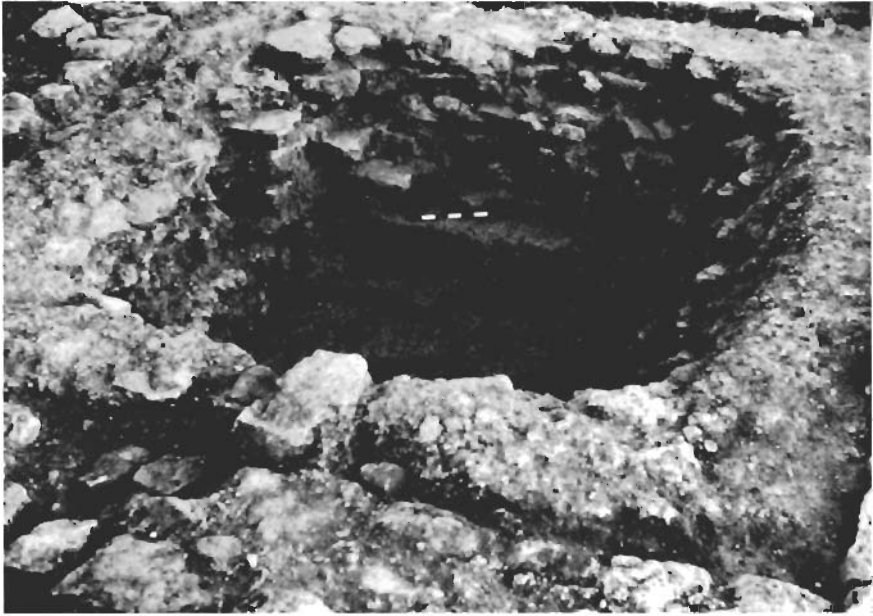
PLATE II. a. Room XIV, South side of cold plunge showing where steps had been
b. Room XIV, Cold plunge, outlet and overflow

north wall of the main building. This room had been floored with *opus signinum* and the walls rendered with painted plaster. Centrally situated in the floor was a sunken cold plunge measuring 3 ft. 9 ins. × 4 ft. 3 ins. and 2 ft. 5 ins. deep. Steps, which had been robbed, had originally led down from the south side (PLATE IIa). The sides of the bath were lined with a red water-proofing cement. The cold plunge had been floored with patterned red tiles, fragments of which were found in situ at the edges.¹²

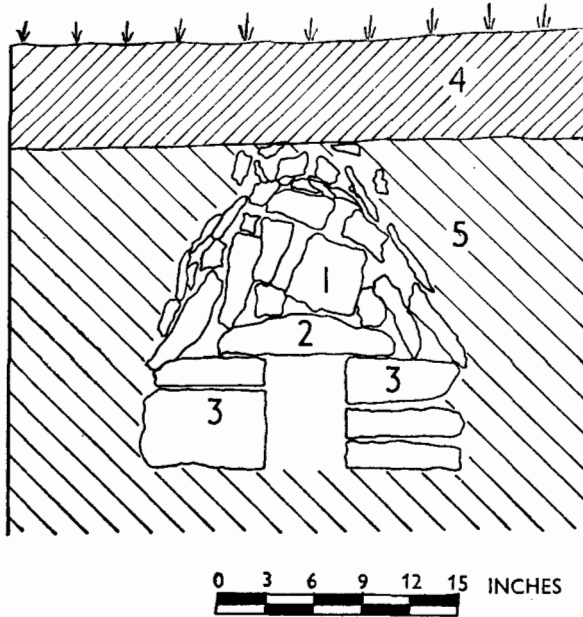
| 1. Hived rough stones. | 4. Humus. |

a channel, the channel was capped, then stone rubble hived over, fairly large stones towards the centre, thin stones on the outside, up to the pervious soil level (FIG. 6). By probing with an iron bar this drain was followed up the slope. It was found that the system cut off
