St Barbara's Simberi Gold Mine

Enhancing Infrastructure Maintenance with RapidBlast™ Wet Abrasive Blast Equipment

CASE STUDY

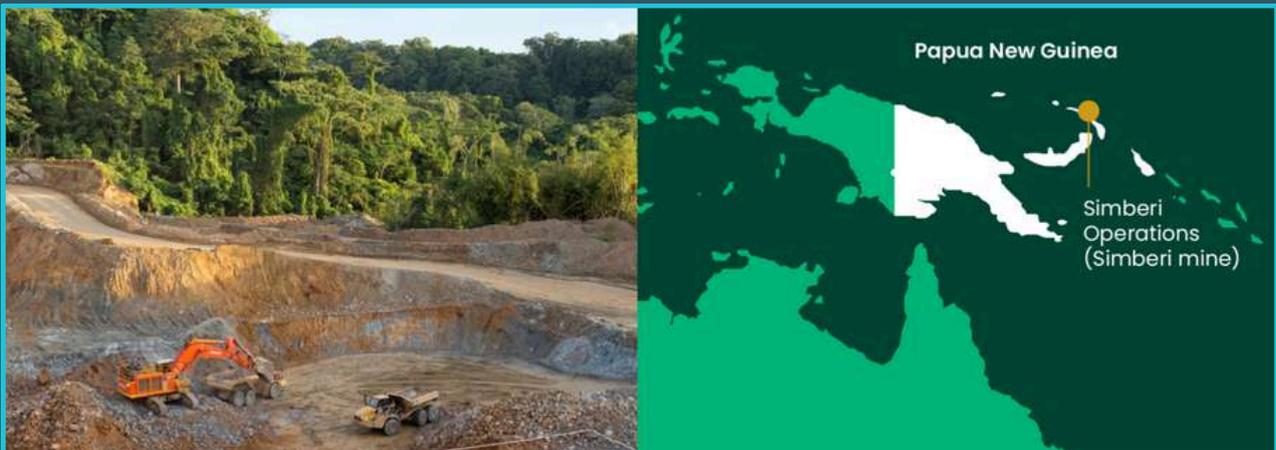
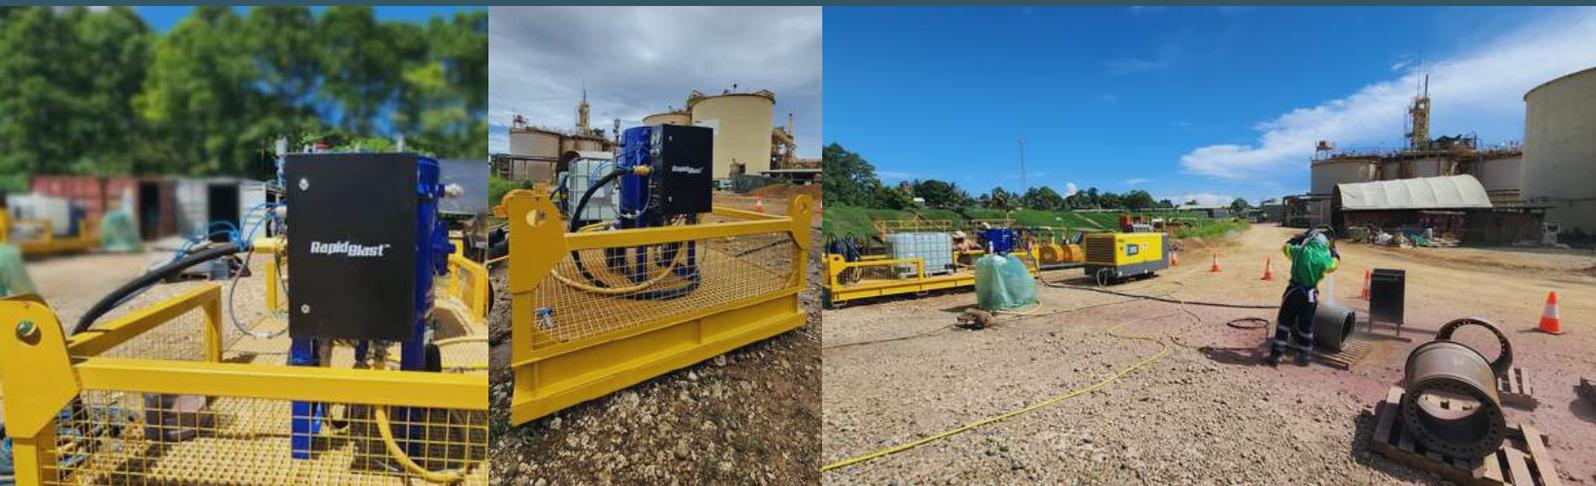
The chosen solution was the RapidBlast™ SD140 Wet Abrasive Blasting Equipment, custom-mounted on a purpose-built, hot-dip galvanized skid designed specifically for the challenging conditions of the Simberi Gold Mine.

Constructed from 8mm stainless steel and adhering to both Australian AS1210 and European CE and ATEX standards, this equipment offers robust performance in explosive environments. It features a 155 Ltr powder coated pressure vessel, designed for ergonomic handling and efficiency, even in the most extreme conditions.

The custom-built platform supports over 3 metric tons, accommodating the RapidBlast equipment, a tonne of garnet, a 1000-liter water tank (IBC), a hose reel, and a water filter system. The skid's bright yellow paint enhances visibility and safety, crucial in the mine's operating environment.
